**Flood Control Project Maintenance  
Levee Inspections**

**Fall 2016 Levee Maintenance Deficiency Summary Report**

**Sacramento River Basin**

| <b>MA0005</b> | Overall LMA Rating | Total LMA Miles | * Overall LMA Threshold Percent is less than 10.00%; however, U Rated Miles are present, so the Overall LMA Rating is M instead of A. | | | | | |
|--|---|---|---|---|---|---|---|---|
| <b>Sutter Maintenance Yard Maintenance Area 0005</b> | <b>M *</b> | <b>32.84</b> | | | | | | |

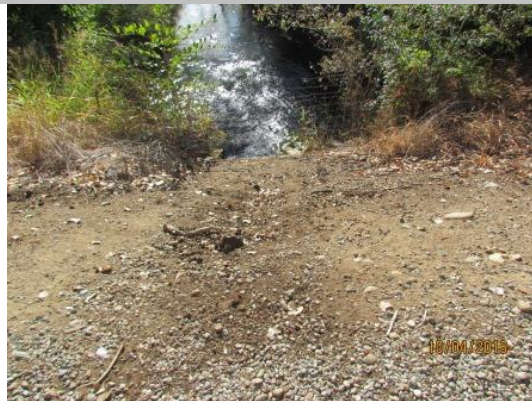
Photo 1 of 1 : FA\_2016\_MA0005\_196\_46\_20161014\_00059.jpg

View of the damaged slope by foot traffic.

| S2 : Repair the levee slope damaged by foot traffic and prevent access where possible. | | | | | |

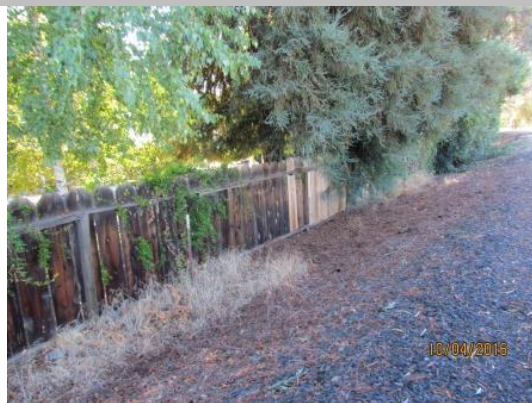
Photo 1 of 1 : FA\_2016\_MA0005\_196\_49\_20161014\_00061.jpg

View of the wood plank fence at the landside toe.

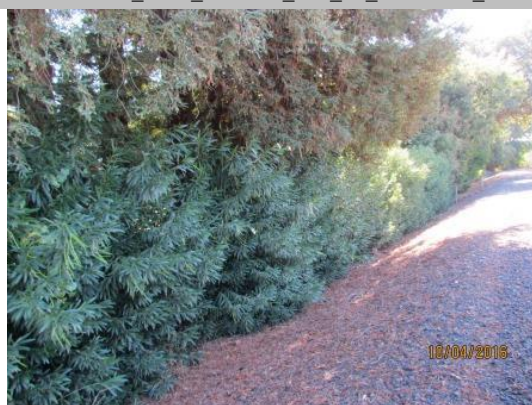
Photo 1 of 1 : FA\_2016\_MA0005\_196\_50\_20161014\_00062.jpg

View of the oleanders along the landside toe.

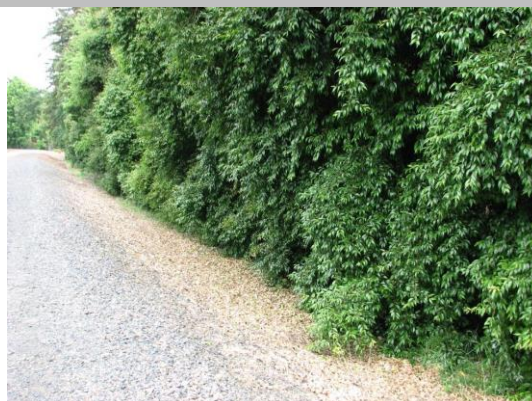
Photo 1 of 1 : FA\_2016\_MA0005\_196\_43\_20160823\_00023.jpg

View of the overgrown vegetation at the landside toe.

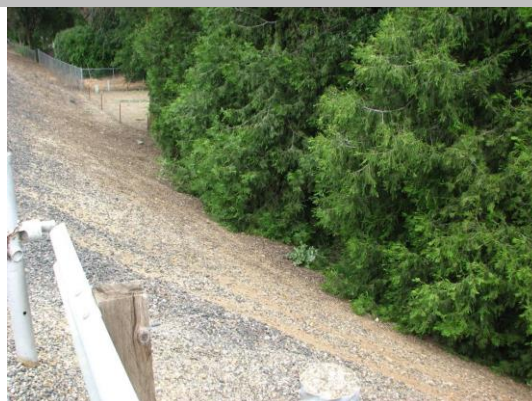
Photo 1 of 1 : FA\_2016\_MA0005\_196\_40\_20160823\_00021.jpg

View of the overgrown cedar trees on the landside toe.

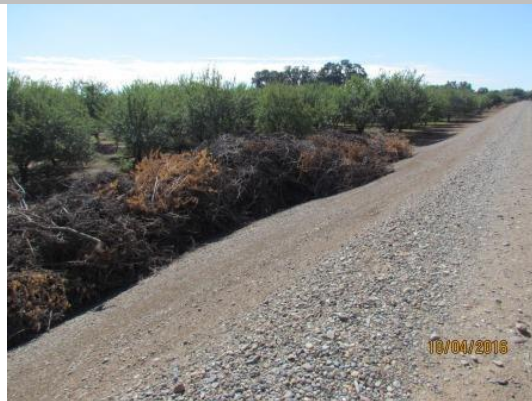
Photo 1 of 1 : FA\_2016\_MA0005\_196\_37\_20161014\_00065.jpg

View of the prunings along the landside toe.

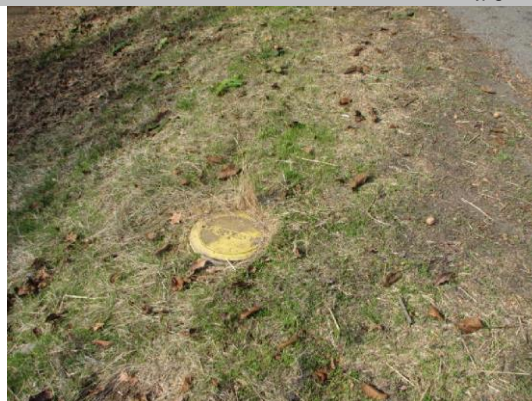
Photo 1 of 2 : UCIP\_FA\_2016\_50846\_67936.jpg

FS\_ID:50846  
DS\_ID:1619  
EP\_NO: 6544-A  
Repair Type: Non-Urgent  
Crossing Status: Indicator Found  
UCIP Comments: 11/15/2016 Crossing appears to be in good condition. (DWR Sutter Yard- A Freitag) 5/9/2016 Crossing appears to be in good condition. 8/5/2015 Pipe is suspected to cross inside of bridge. 12/8/2014 Same as last inspection. 6/11/2014 Same as last inspection. 11/20/2013 Same as last inspection. 5/29/2013 Same as last inspection. 10/30/2012 Pipeline should be marked where pipe crosses levee as it is 4-feet below the surface.  
FIELD\_STRUCT\_DESC: 6-inch concrete encased steel high pressure gas pipeline through the levee, 4 feet below the crown. 8-inch diameter Pacific Gas & Electric gas access manhole located on the south side of the road 250-feet east of the levee crown. (Permit No. 6544A, 1969 - Pacific Gas & Electric) [Additional Reference(s): DWR Levee Log, 1990].  
FS Date: 11/21/2016 1:36:44 PM

PG&E access lid on south edge of roadway.

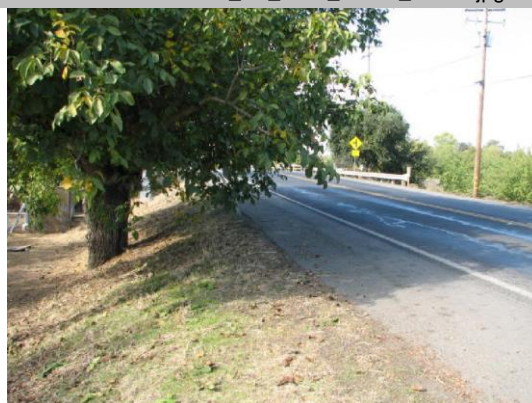
Photo 2 of 2 : UCIP\_FA\_2016\_50846\_67935.jpg

Location of PG&E access lid 250-feet east of levee crown on south side of roadway.

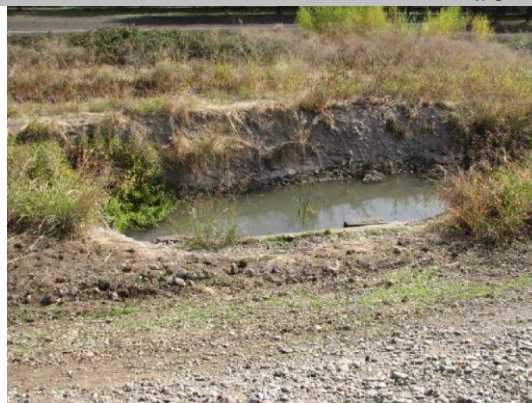
Photo 1 of 2 : UCIP\_FA\_2016\_50847\_67939.jpg

| FS_ID:50847<br>DS_ID:1768<br>EP_NO: N/A<br>Repair Type: Non-Urgent<br>Crossing Status: Found<br>UCIP Comments: 11/15/2016 Abandoned. Needs standpipe cover. (DWR Sutter Yard- A Freitag)5/9/2016 Abandoned pipe. Needs a cover for standpipe.8/5/2015 Abandoned pipes. Need covers made for tops of standpipes to prevent falls. 12/8/2014 Same as last inspection.6/11/2014 Same as last inspection.11/19/2013 Same as last inspection.5/29/2013 Same as last inspection. Land owner said pipes are abandoned and no longer used. Covers should be made for top of standpipe to prevent falls. Pipes should be properly abandoned.10/30/2012 Pipe 1/2 filled with soil at slide gate on WS. FIELD_STRUCT_DESC: *ABANDONED* 2 of 2: 36-inch corrugated metal drainage pipe through the levee, 11 feet below the crown. Slide gate in a 54-inch corrugated metal riser on the waterside (WS) slope. Concrete "U" shaped headwall on the landside (LS). [Additional Reference(s): DWR Levee Log, 1990. Sacramento O&M Manual 516, April 1960 (Station 470+00)].<br>FS Date: 11/21/2016 1:38:13 PM | | | | | |

Headwall at LS toe.

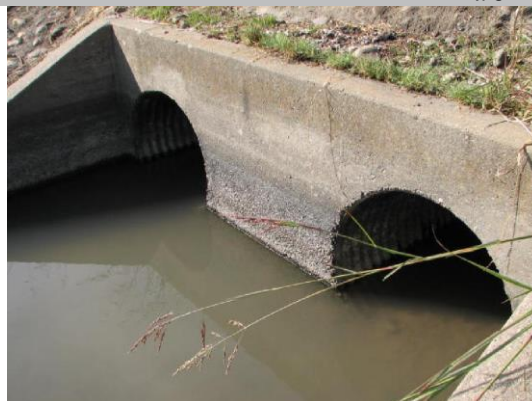
Photo 2 of 2 : UCIP\_FA\_2016\_50847\_67938.jpg

| FS_ID:50847<br>DS_ID:1768<br>EP_NO: N/A<br>Repair Type: Non-Urgent<br>Crossing Status: Found<br>UCIP Comments: 11/15/2016 Abandoned. Needs standpipe cover. (DWR Sutter Yard- A Freitag)5/9/2016 Abandoned pipe. Needs a cover for standpipe.8/5/2015 Abandoned pipes. Need covers made for tops of standpipes to prevent falls. 12/8/2014 Same as last inspection.6/11/2014 Same as last inspection.11/19/2013 Same as last inspection.5/29/2013 Same as last inspection. Land owner said pipes are abandoned and no longer used. Covers should be made for top of standpipe to prevent falls. Pipes should be properly abandoned.10/30/2012 Pipe 1/2 filled with soil at slide gate on WS. FIELD_STRUCT_DESC: *ABANDONED* 2 of 2: 36-inch corrugated metal drainage pipe through the levee, 11 feet below the crown. Slide gate in a 54-inch corrugated metal riser on the waterside (WS) slope. Concrete "U" shaped headwall on the landside (LS). [Additional Reference(s): DWR Levee Log, 1990. Sacramento O&M Manual 516, April 1960 (Station 470+00)].<br>FS Date: 11/21/2016 1:38:13 PM | | | | | | |

Headwall at LS toe.

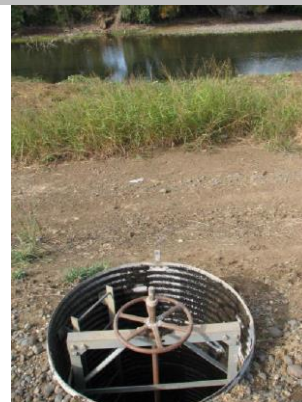
Photo 2 of 2 : UCIP\_FA\_2016\_50848\_67940.jpg

| FS_ID:50848<br>DS_ID:1620<br>EP_NO: N/A<br>Repair Type: Non-Urgent<br>Crossing Status: Found<br>UCIP Comments: 11/15/2016 Abandoned. Needs cover for the standpipe. (DWR Sutter Yard- AFreitag)5/9/2016 Abandoned pipe. Needs a cover for the standpipe.8/5/2015 Abandoned crossing. Covers need to be made for tops of standpipes to prevent falls.12/8/2014 Same as last inspection.6/11/2014 Same as last inspection.11/19/2013 Same as last inspection.5/29/2013 Same as last inspection. Land owner said pipes are abandoned and no longer used. Covers should be made for top of standpipe to prevent falls. Pipes should be properly abandoned.10/30/2012 Pipe 1/2 filled with soil at slide gate end.<br>FIELD_STRUCT_DESC: *ABANDONED* 1 of 2: 36-inch drainage pipe through the levee, 11 feet below the crown. Slide gate in a 54-inch corrugated metal riser on the waterside (WS) slope. Concrete "U" headwall on the landside (LS). [Additional Reference(s): DWR Levee Log, 1990. Sacramento O&M Manual 516, April 1960 (Station 470+00)].<br>FS Date: 11/21/2016 1:39:16 PM | | | | | |

54-inch CMP riser and slide gate on WS shoulder.

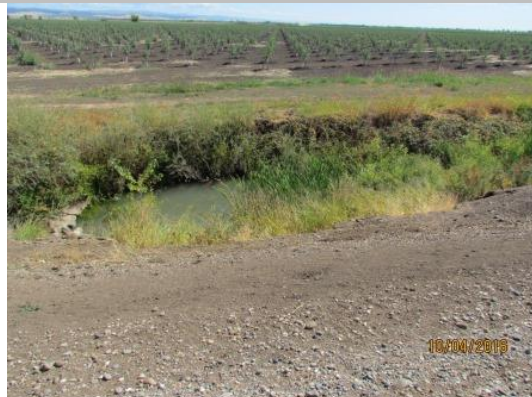
Photo 2 of 2 : FA\_2016\_MA0005\_196\_56\_20161014\_00070.jpg

Another view of the landside toe erosion.

| E2 : Schedule repair of erosion site prior to the next inspection. | | | | | |

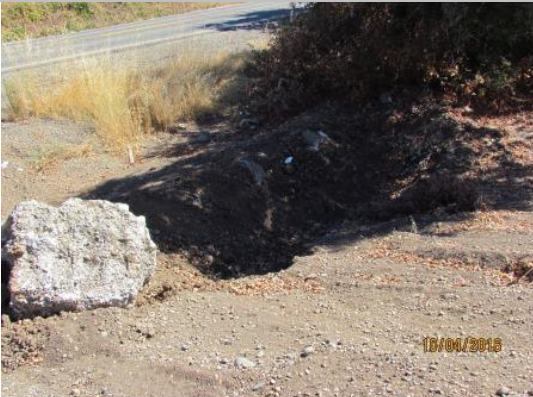
Photo 1 of 1 : FA\_2016\_MA0005\_196\_59\_20161014\_00073.jpg

View of the rocks and cut in the landside levee toe.

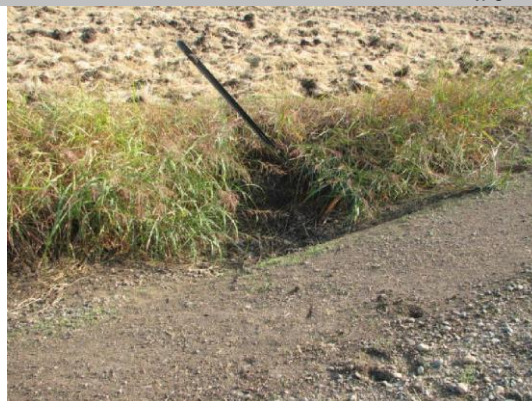
Photo 1 of 2 : UCIP\_FA\_2016\_50864\_67970.jpg

FS\_ID:50864  
DS\_ID:1628  
EP\_NO: N/A  
Repair Type: Non-Urgent  
Crossing Status: Found  
UCIP Comments: 11/15/2016 Appears abandoned and should be done so properly. (DWR Sutter Yard- AFreitag)5/11/2016 Possibly an abandoned crossing. LS inlet was over 50% buried and nothing was found on the WS.8/4/2015 LS pipe end filled about 50% with soil and WS pipe end is buried.12/8/2014 Same as last inspection.6/11/2014 Same as last inspection.11/19/2013 Same as last inspection.5/29/2013 Same as last inspection.10/30/2012 Pipe filled with soil and outlet/appurtenances are buried.  
FIELD\_STRUCT\_DESC: \*ABANDONED\* 24-inch corrugated metal drainage pipe through the levee, 8.5 feet below the crown. Flap gate on the waterside (WS). Concrete "U" shaped headwall on the landside (LS) toe. [Additional Reference(s): DWR Levee Log, 1990. Sacramento O&M Manual 515, April 1955 (Station 576+72), USACE As-built Drawings 50-4-2637, Exhibit B, Sheet 2, April 1950 (station 576+72.4)].

Headwall at LS toe.

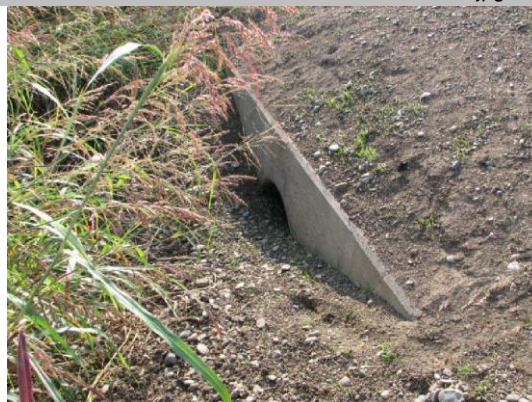
Photo 2 of 2 : UCIP\_FA\_2016\_50864\_67969.jpg

Headwall at LS toe.

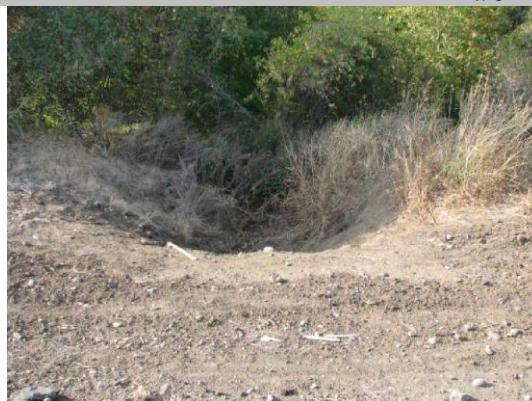
Photo 1 of 2 : UCIP\_FA\_2016\_50865\_67973.jpg

FS\_ID:50865  
DS\_ID:1629  
EP\_NO: N/A  
Repair Type: Non-Urgent  
Crossing Status: Found  
UCIP Comments: 11/15/2016 LS inlet was unburied and entire pipe is about 25% full of soil. WS flapgate was shut and partially buried. (DWR Sutter Yard- A Freitag) 5/11/2016 WS flap gate was about 50% buried and LS was 100% buried. Appears to be an abandoned crossing. 8/4/2015 WS flap gate is partially buried by soil and being overgrown with vegetation. LS pipe end was underwater and suspected to still be completely buried with soil. 12/8/2014 Same as last inspection. 6/11/2014 Same as last inspection. 11/19/2013 Same as last inspection. 5/29/2013 Same as last inspection. 10/30/2012 Pipe filled with soil.  
FIELD\_STRUCT\_DESC: 24-inch corrugated metal drainage pipe through the levee, 9.3 feet below the crown. Flap gate on the waterside (WS). Concrete headwall at the landside (LS) and the WS toes.  
[Additional Reference(s): DWR Levee Log, 1990. Sacramento O&M 515, April 1955 (Station 609+79). USACE As-Built Drawing 50-4-2637, Exhibit B, Sheet 3, April 1950 (Station 609+78.5)].

Outlet at WS toe.

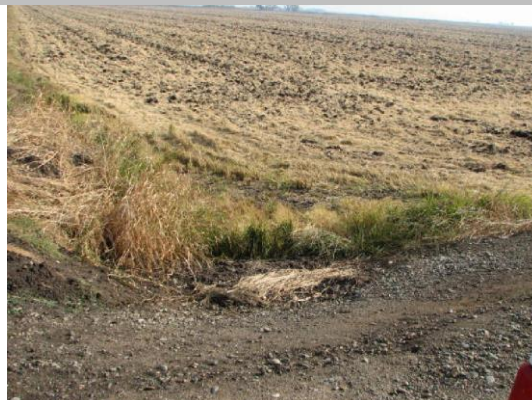
Photo 2 of 2 : UCIP\_FA\_2016\_50865\_67972.jpg

Buried inlet at LS toe.

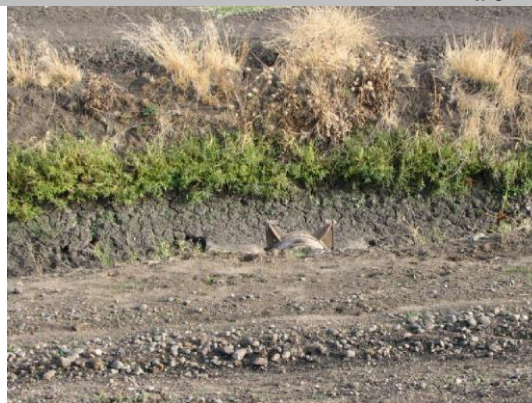
Photo 1 of 1 : UCIP\_FA\_2016\_50873\_67986.jpg

| FS_ID:50873<br>DS_ID:1633<br>EP_NO: N/A<br>Repair Type: Non-Urgent<br>Crossing Status: Found<br>UCIP Comments: 11/15/2016 Abandoned. (DWR Sutter Yard-AFreitag)5/11/2016 Abandoned crossing.8/4/2015 Abandoned pipe. Casey Wilder has started the steps to have the pipe properly abandoned and removed from the levee.12/8/2014 Same as last inspection.6/11/2014 Same as last inspection.11/19/2013 Same as last inspection.5/29/2013 Same as last inspection.10/30/2012 Pipe and headwall buried on WS, no access to slide gate.<br>FIELD_STRUCT_DESC: 24-inch corrugated metal irrigation pipe through the levee, 12.5 feet below the crown. Slide gate on the waterside (WS). Flap gate and headwall on the landside (LS). Concrete headwall at the WS toe. [Additional Reference(s): DWR Levee Log, 1990. Sacramento O&M Manual 515, April 1955 (Station 706+00)].<br>FS Date: 11/21/2016 2:20:10 PM | | | | | |

Flap gate and headwall at LS toe in irrigation or drainage ditch.

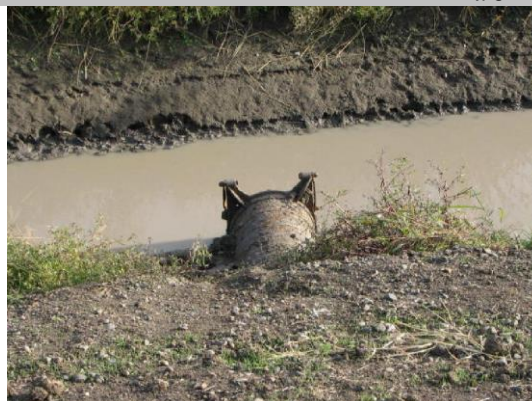
Photo 1 of 2 : UCIP\_FA\_2016\_50874\_67989.jpg

FS\_ID:50874  
DS\_ID:1634  
EP\_NO: N/A  
Repair Type: Non-Urgent  
Crossing Status: Found  
UCIP Comments: 11/15/2016 Abandoned. (DWR Sutter Yard-AFreitag)5/11/2016 Abandoned crossing.8/4/2015 Abandoned pipe. Casey Wilder has started the steps to have the pipe properly abandoned and removed from the levee.12/8/2014 Same as last inspection.6/11/2014 Same as last inspection.11/19/2013 Same as last inspection.5/29/2013 Same as last inspection.  
FIELD\_STRUCT\_DESC: 24-inch corrugated metal irrigation pipe through the levee, 14.5 feet below the crown. Slide gate on the waterside (WS) on concrete headwall. Flap gate on the landside (LS).  
[Additional Reference(s): DWR Levee Log, 1990. Sacramento O&M Manual 515, April 1955 (Station 717+50)].  
FS Date: 11/21/2016 2:25:16 PM

Pipe and flap gate on LS toe.

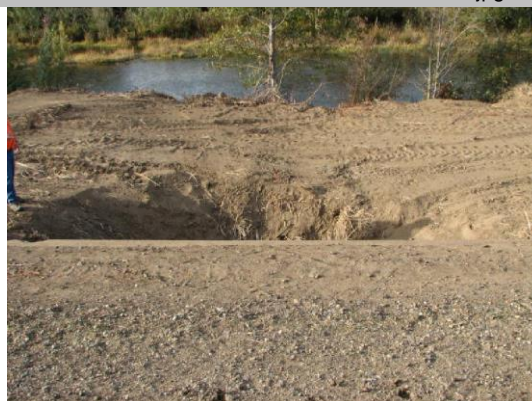
Photo 2 of 2 : UCIP\_FA\_2016\_50874\_67988.jpg

headwall at WS toe.

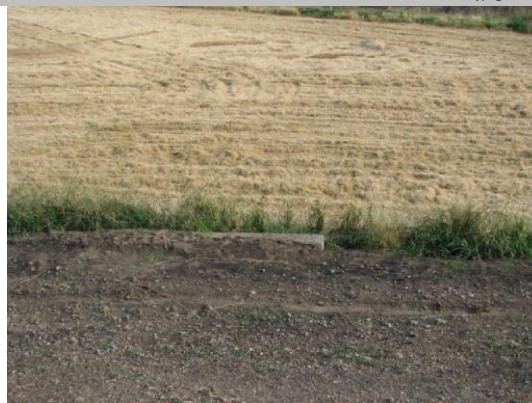
Photo 1 of 2 : UCIP\_FA\_2016\_50875\_67991.jpg

| FS_ID:50875<br>DS_ID:1635<br>EP_NO: N/A<br>Repair Type: Non-Urgent<br>Crossing Status: Found<br>UCIP Comments: 11/15/2016 Abandoned. (DWR Sutter Yard-AFreitag)5/11/2016 Abandoned crossing.8/4/2015 Abandoned pipe. Casey Wilder has started the steps to have the pipe properly abandoned and removed from the levee.12/8/2014 Same as last inspection.6/11/2014 Same as last inspection.11/19/2013 Same as last inspection.5/29/2013 Same as last inspection.10/30/2012 Pipe buried on both sides of levee.<br>FIELD_STRUCT_DESC: *ABANDONED* 30-inch corrugated metal drainage pipe through the levee, 12.2 feet below the crown. Flap gate on the waterside (WS) end. [Additional Reference(s): DWR Levee Log, 1990. USACE Sacramento O&M Manual 515, April 1955 (Station 748+53). USACE As-built Drawing 50-4-2637, Exhibit B, Sheet 4, April 1950 (Station 748+53)].<br>FS Date: 11/21/2016 2:26:09 PM | | | | | |

Concrete headwall at LS toe.

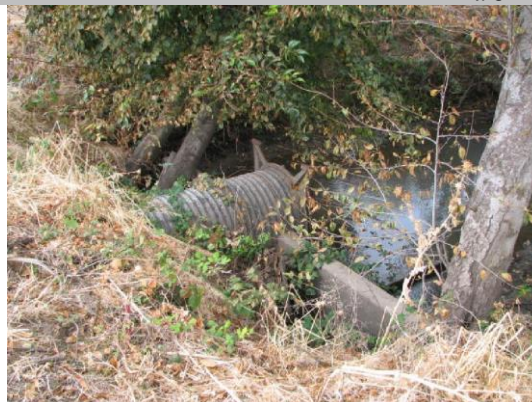
Photo 2 of 2 : UCIP\_FA\_2016\_50891\_68032.jpg

FS\_ID:50891  
DS\_ID:1639  
EP\_NO: N/A  
Repair Type: Non-Urgent  
Crossing Status: Found  
UCIP Comments: 11/15/2016 NO soil supporting the WS wing walls. (DWR Sutter Yard- A Freitag) 5/11/2016 Still no soil supporting the WS wing walls and apron. WS vegetation was thinner and not a problem this time. 8/4/2015 No soil supporting the WS wing walls at the WS pipe end. WS pipe end is also being overgrown with vegetation and should be cleared back. 6/11/2014 Same as last inspection. 11/19/2013 Same as last inspection. 5/29/2013 Same as last inspection. 10/31/2012 Soil under Concrete wing walls on WS toe has been eroded. No soil supporting wing walls.  
FIELD\_STRUCT\_DESC: 36-inch corrugated metal drainage pipe through the levee, 13 feet below the crown. Flap gate on the waterside (WS). Concrete headwall on the landside (LS) and the WS ends.  
[Additional Reference(s): DWR Levee Logs, 1990. USACE Sacramento O&M Manual 515, April 1955 (Station 978+25). USACE As-built Drawing 50-4-2637, Exhibit B, Sheet 5, April 1950 (Station 978+24.95)].

CMP pipe, flap gate, and headwall on WS toe.

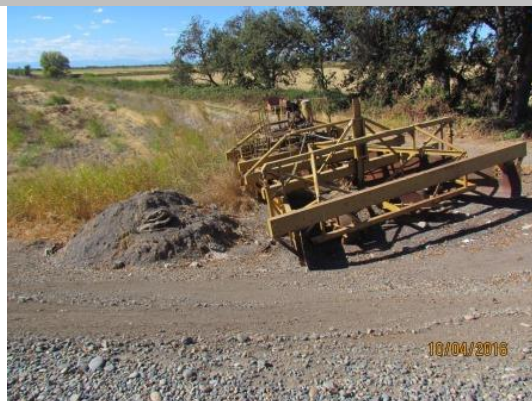
Photo 1 of 1 : FA\_2016\_MA0005\_197\_48\_20161014\_00068.jpg

View of soil pile, rocks, and ag equipment.

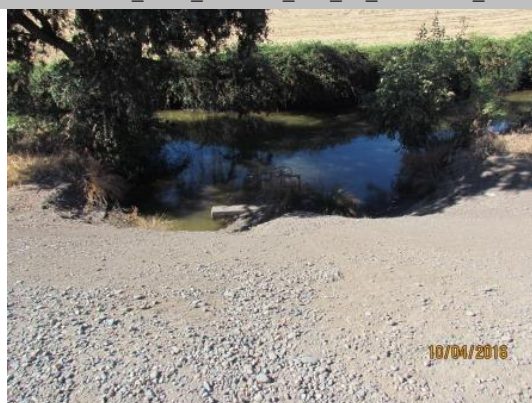
Photo 1 of 1 : FA\_2016\_MA0005\_197\_49\_20161014\_00069.jpg

View of the landside toe erosion.

| E2 : Schedule repair of erosion site prior to the next inspection. | | | | | |
| Repair the erosion on the waterside toe of the levee. | | | | | |

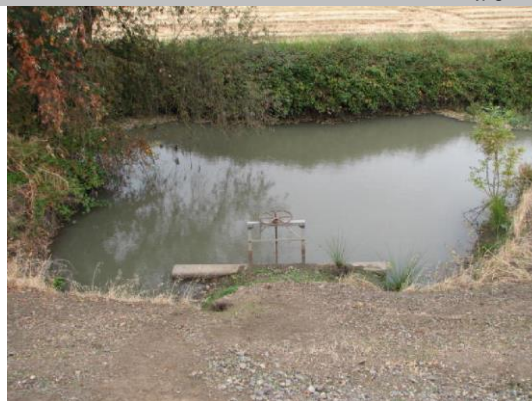
Photo 1 of 2 : UCIP\_FA\_2016\_50904\_68498.jpg

FS\_ID:50904  
DS\_ID:1645  
EP\_NO: N/A  
Repair Type: Urgent  
Crossing Status: Found  
UCIP Comments: 11/14/2016 LS erosion still present and is into the prism of the levee. WS flap gate was still mostly buried and non-operational. 5/23/2016 The tree that was overgrowing the WS flapgate has been removed. Flap gate was half buried and unable to open. Erosion on the LS is still present. (DWR Sutter Yard - afreitag)7/28/2015 LS inlet is underwater but there appears to be erosion behind the LS headwall. WS pipe end and flap gate are completely overgrown and inaccessible for inspection. (DWR Sutter Yard - afreitag)11/25/2014 Tree is overgrowing the WS pipe outlet.. Needs to be trimmed back. (DWR Sutter Yard - afreitag)6/4/2014 Same as last inspection. (DWR Sutter Yard - afreitag)11/12/2013 Same as last inspection. (DWR Sutter Yard - afreitag)6/6/2013 Same as last inspection. (DWR Sutter Yard - afreitag)10/31/2012 Vegetation needs to be cleared from outlet. (DWR UCIP - wwylie)

Concrete headwall and slide gate on LS toe.

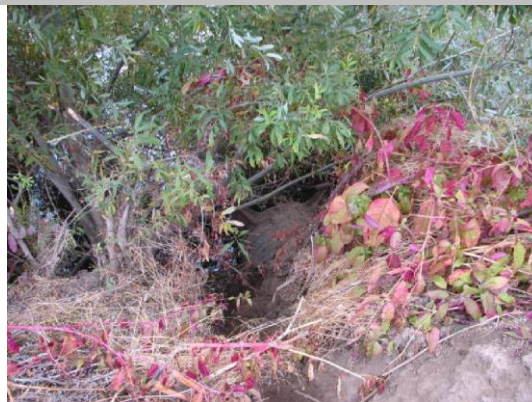
Photo 2 of 2 : UCIP\_FA\_2016\_50904\_68497.jpg

Flap gate on WS slope.

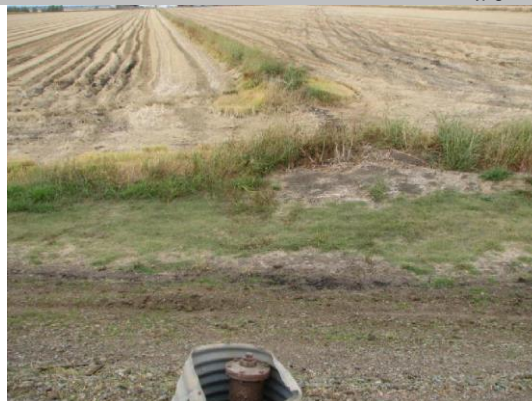
Photo 1 of 2 : UCIP\_FA\_2016\_50905\_68057.jpg

| FS_ID:50905<br>DS_ID:1646<br>EP_NO: 3927<br>Repair Type: Non-Urgent<br>Crossing Status: Found<br>UCIP Comments: 11/14/2016 Appears abandoned- pump removed from pier in Butte Creek also riser and siphon breaker are no longer seen on LS shoulder. (DWR Sutter Yard- A Freitag)5/23/2016 Crossing appears to have been abandoned and removed. Could not locate the LS riser and siphon breaker.7/28/2015 No pump present during any of my inspections. Crossing appears abandoned. CMP riser has been knocked out of levee. 11/25/2014 Same as last inspection.6/04/2014 Same as last inspection.11/12/2013 Same as last inspection.6/6/2013 Same as last inspection.10/31/2012 Pump does not appear to be in use or is abandoned.<br>FIELD_STRUCT_DESC: 20-inch (not 18-inch as referenced in the levee log) exterior coated steel irrigation pipe through the levee, 2.4 feet below the crown. Siphon breaker in a 24-inch corrugated metal riser on the landside (LS) shoulder. Portable pump on the waterside (WS). (Permit No. 3927, 1962 - Arrowhead Ranch). [Additional Reference(s): DWR Levee Log, 1990].<br>FS Date: 11/22/2016 9:26:11 AM | | | | | |

Air vent in 24-inch CMP riser on LS shoulder.

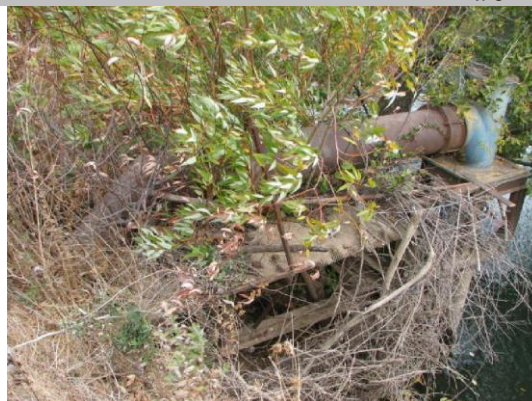
Photo 2 of 2 : UCIP\_FA\_2016\_50905\_68056.jpg

| FS_ID:50905<br>DS_ID:1646<br>EP_NO: 3927<br>Repair Type: Non-Urgent<br>Crossing Status: Found<br>UCIP Comments: 11/14/2016 Appears abandoned- pump removed from pier in Butte Creek also riser and siphon breaker are no longer seen on LS shoulder. (DWR Sutter Yard- A Freitag)5/23/2016 Crossing appears to have been abandoned and removed. Could not locate the LS riser and siphon breaker.7/28/2015 No pump present during any of my inspections. Crossing appears abandoned. CMP riser has been knocked out of levee. 11/25/2014 Same as last inspection.6/04/2014 Same as last inspection.11/12/2013 Same as last inspection.6/6/2013 Same as last inspection.10/31/2012 Pump does not appear to be in use or is abandoned.<br>FIELD_STRUCT_DESC: 20-inch (not 18-inch as referenced in the levee log) exterior coated steel irrigation pipe through the levee, 2.4 feet below the crown. Siphon breaker in a 24-inch corrugated metal riser on the landside (LS) shoulder. Portable pump on the waterside (WS). (Permit No. 3927, 1962 - Arrowhead Ranch). [Additional Reference(s): DWR Levee Log, 1990].<br>FS Date: 11/22/2016 9:26:11 AM | | | | | |

Pump on metal pier at WS toe.

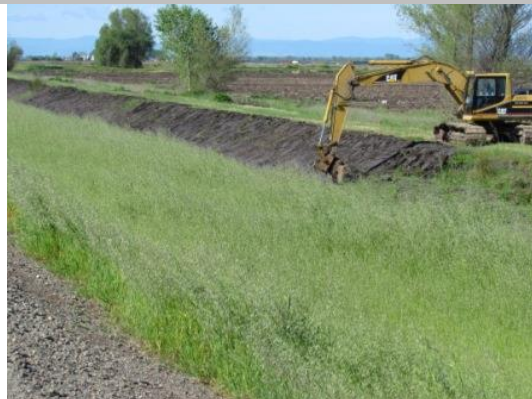
Photo 1 of 1 : FA\_2016\_MA0005\_197\_7\_20160823\_00004.jpg

View of the agricultural ditch along the landside toe.

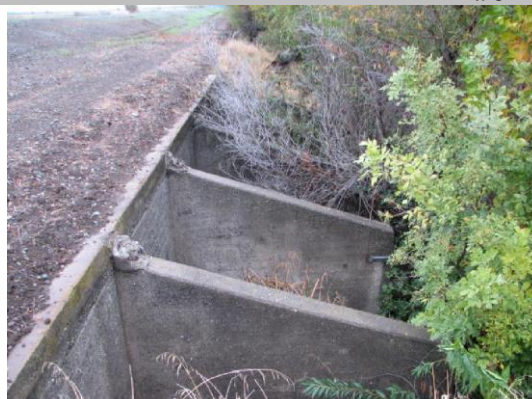
Photo 2 of 2 : UCIP\_FA\_2016\_48780\_68083.jpg

FS\_ID:48780  
DS\_ID:16300  
EP\_NO: N/A  
Repair Type: Non-Urgent  
Crossing Status: Found  
UCIP Comments: 5/23/2016 Crossing is not abandoned. Water was flowing through from the LS to WS. LS pipe inlet is about 100 yds from LS levee toe across the LS canal.7/28/2015 Crossing is listed as abandoned but it is not filled with concrete like crossings 1-4 here.11/25/2014 Same as last inspection.6/04/2014 Same as last inspection.11/13/2013 Same as last inspection.6/6/2013 Sutter Maintenance Yard supervisor Jason Cooper said there is a flap gate on the LS end of the pipe in the western most ditch to prevent high water flooding. Not sure if this is adequate, will talk to levee inspector to find out.11/01/2012 Pipe open on WS and is not filled with concrete.  
FIELD\_STRUCT\_DESC: 5 of 5: 60-inch corrugated metal drainage (originally irrigation) pipe through the levee, 16.6 feet below the crown. Concrete headwall on the landside (LS) and the waterside (WS) shoulders. Pipe partially plugged on the LS with a concrete wall. Flap gate installed on the concrete plug to allow floodwater from the LS to flow to the WS (Use changed after western canal realignment under Permit No. 16667, 1997 - Western Canal WD). [Additional Reference(s): DWR Levee Logs, 1990. USACE Sacramento O&M Manual 515, April 1955 (Station 2+00"A")].

Concrete headwall on WS shoulder.

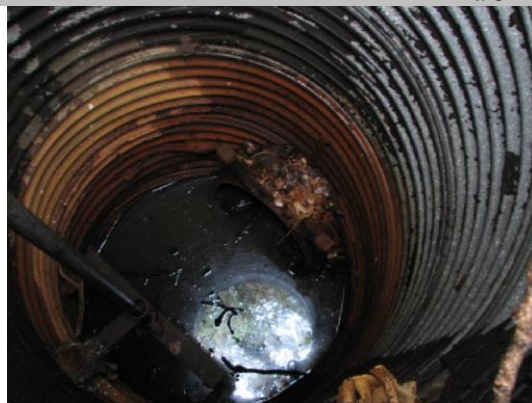
Photo 1 of 2 : UCIP\_FA\_2016\_50920\_68105.jpg

| FS_ID:50920<br>DS_ID:1650<br>EP_NO: N/A<br>Repair Type: Non-Urgent<br>Crossing Status: Found<br>UCIP Comments: 11/14/2016 Abandoned. (DWR Sutter Yard-AFreitag)5/23/2016 Abandoned7/28/2015 Abandoned- still cannot locate a LS ans WS pipe end.11/25/2014 Same as last inspection.6/04/2014 Same as last inspection.11/12/2013 Same as last inspection.6/6/2013 Same as last inspection.10/31/2012 Appears abandoned. Unable to locate outfall on WS. Unable to locate inlet on LS.<br>FIELD_STRUCT_DESC: *ABANDONED* 24-inch corrugated metal drainage pipe through the levee, 12.5 feet below the crown. Slide gate and flap gate in a 56-inch corrugated metal riser on the waterside (WS) berm. Flap gate on the WS. [Additional Reference(s): DWR Levee Logs, 1990. USACE Sacramento O&M Manual 515, April 1955 (Station 688+40). USACE As-built Drawing 50-4-2637, Exhibit B, Sheet 3, April 1950 (Station 688+40)].<br>FS Date: 11/22/2016 10:09:44 AM | | | | | |

Slide gate and flap gate inside CMP riser on WS berm.

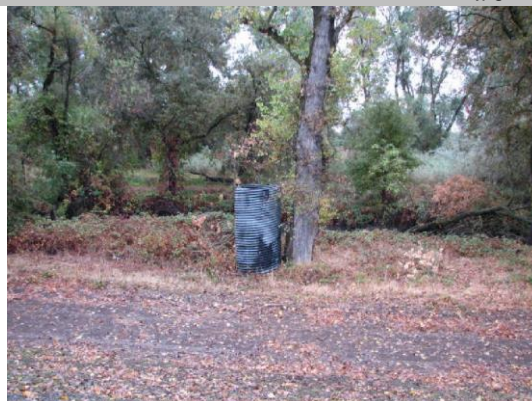
Photo 2 of 2 : UCIP\_FA\_2016\_50920\_68104.jpg

56-inch CMP riser on WS berm.

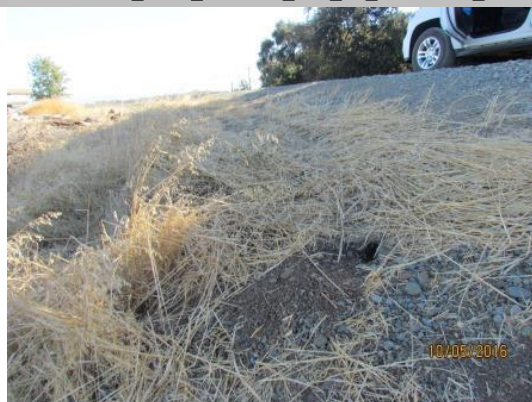
Photo 1 of 1 : FA\_2016\_MA0005\_197\_52\_20161014\_00072.jpg

View of the rodent holes along the landside slope.

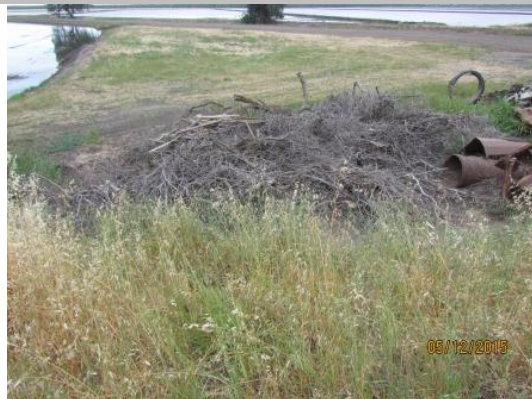
Photo 1 of 1 : FA\_2016\_MA0005\_197\_34\_20160823\_00012.jpg

View of the prunings along the landside toe.

| Remove the prunings and broken metal and concrete pipes from the landside toe. | | | | | |

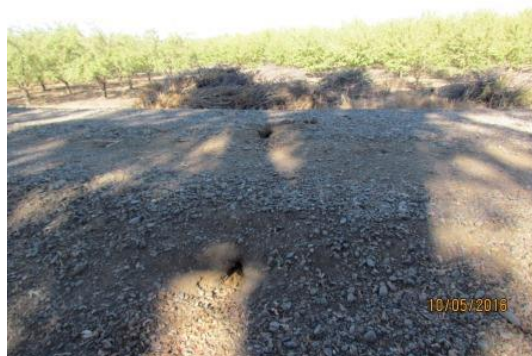
Photo 2 of 2 : FA\_2016\_MA0005\_197\_53\_20161014\_00075.jpg

View of the rodent holes along the crown and waterside slope.

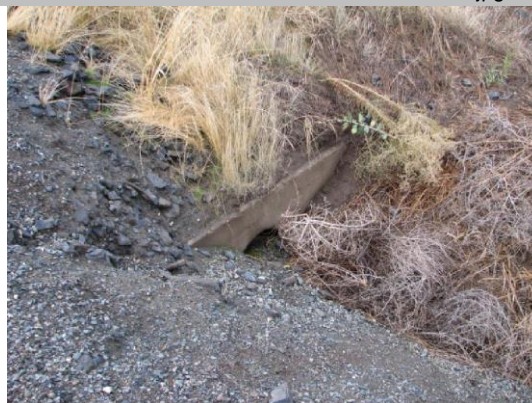
Photo 2 of 2 : UCIP\_FA\_2016\_50930\_68128.jpg

Concrete headwall on LS toe.

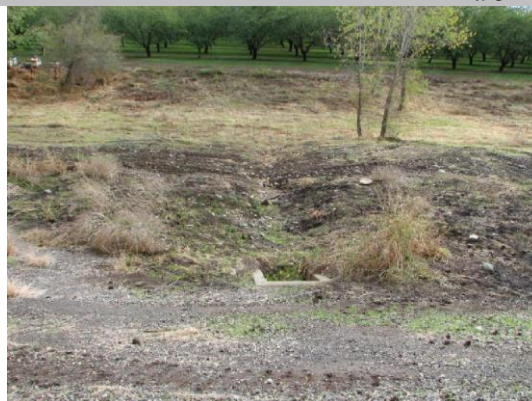
Photo 1 of 2 : UCIP\_FA\_2016\_50940\_68406.jpg

WS outlet and concrete U shaped headwall.

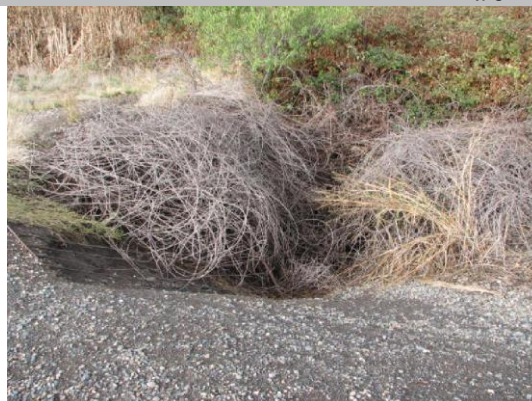
Photo 2 of 2 : UCIP\_FA\_2016\_50940\_68404.jpg

Brambles and soil over pipe at inlet.

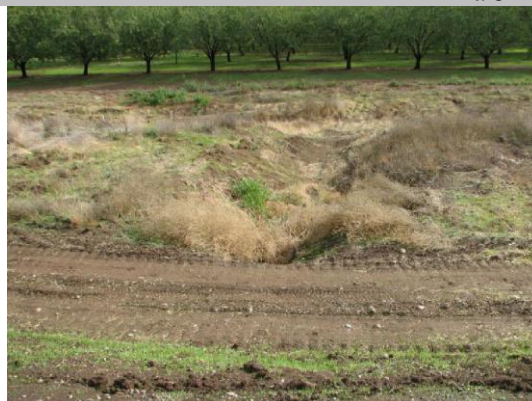
Photo 1 of 2 : UCIP\_FA\_2016\_50942\_68417.jpg

View of outlet looking toward WS toe.

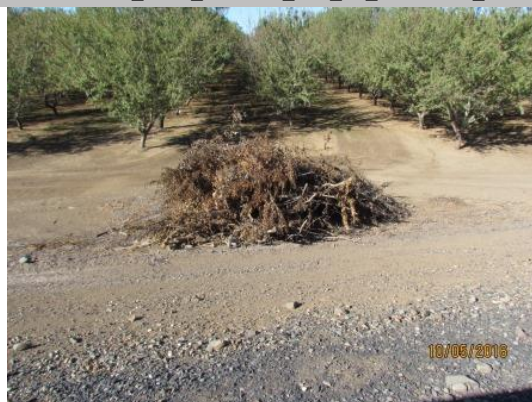
Photo 1 of 1 : FA\_2016\_MA0005\_197\_56\_20161014\_00079.jpg

View of the prunings along the landside toe.

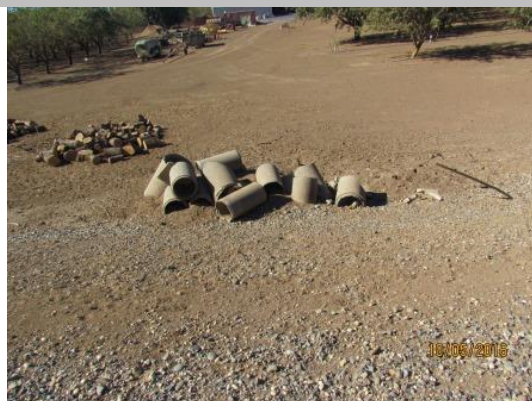
Photo 1 of 1 : FA\_2016\_MA0005\_197\_57\_20161014\_00080.jpg

View of the broken concrete pipes along the landside toe.

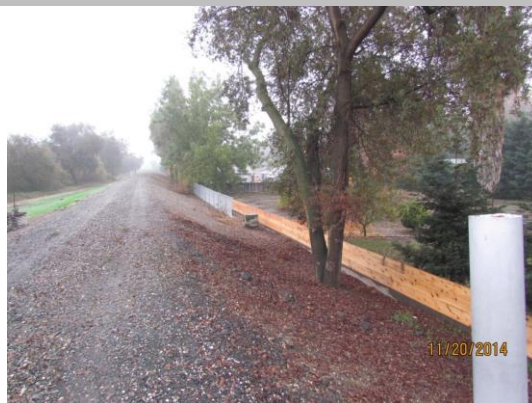
Photo 1 of 1 : FA\_2016\_MA0005\_197\_41\_20160823\_00017.jpg

View of the new fence along the landside toe.

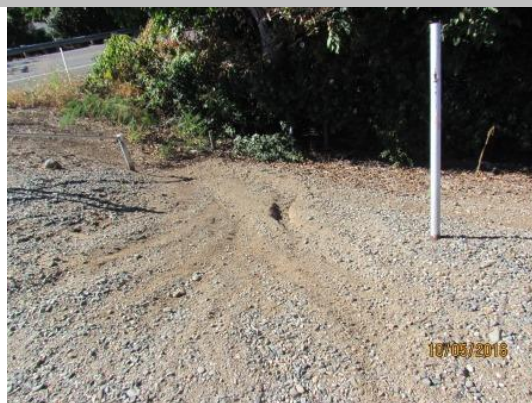
Photo 1 of 1 : FA\_2016\_MA0005\_197\_58\_20161014\_00081.jpg

View of the damaged landside slope.

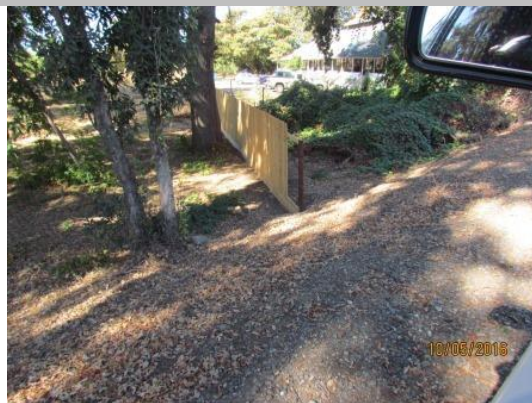
Photo 1 of 1 : FA\_2016\_MA0005\_197\_60\_20161014\_00082.jpg

View of a newly constructed fence.

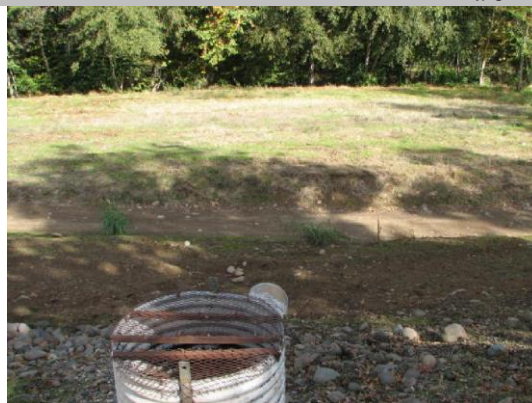
Photo 1 of 2 : UCIP\_FA\_2016\_50947\_68429.jpg

CM riser on WS shoulder-missing slide gate.

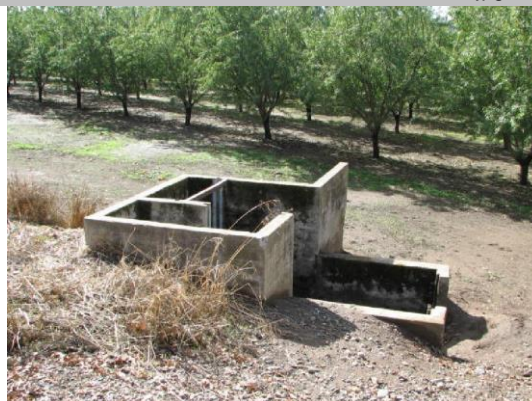
Photo 2 of 2 : UCIP\_FA\_2016\_50947\_68433.jpg

Distribution box on LS toe. Missing slide gate at pipe entrance.

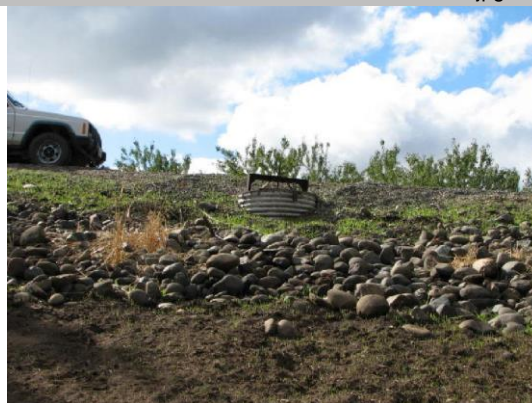
Photo 2 of 2 : UCIP\_FA\_2016\_50948\_68435.jpg

CM riser with slide gate on WS shoulder.

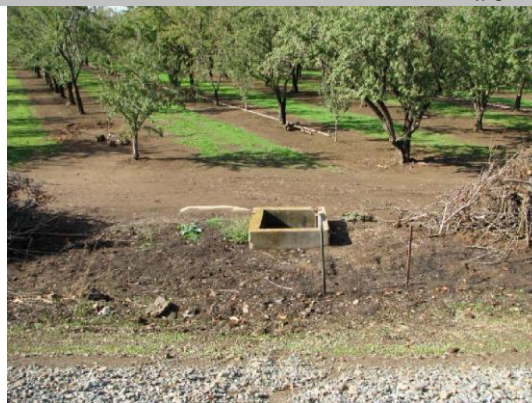
Photo 1 of 2 : UCIP\_FA\_2016\_50949\_68439.jpg

5X5 concrete distribution box at LS toe.

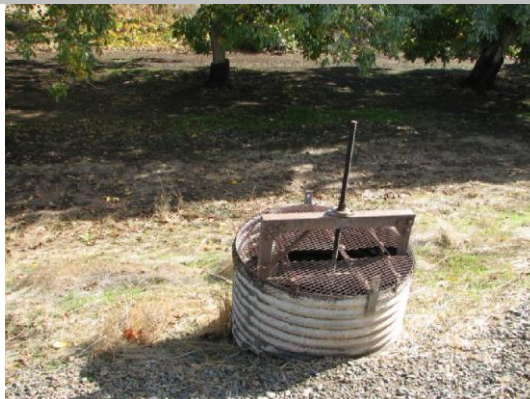
Photo 2 of 2 : UCIP\_FA\_2016\_50949\_68438.jpg

42-inch CMP riser on WS shoulder with slide gate.

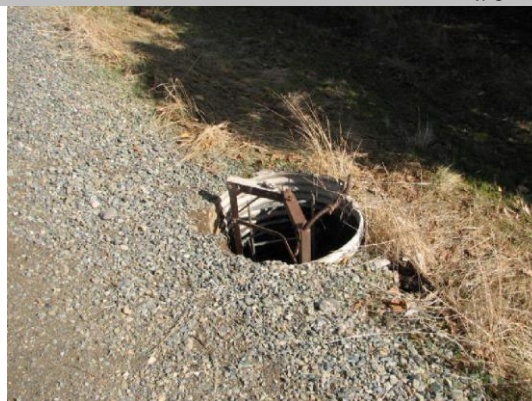
Photo 1 of 2 : UCIP\_FA\_2016\_50950\_68465.jpg

Broken slide gate in CM riser on WS slope.

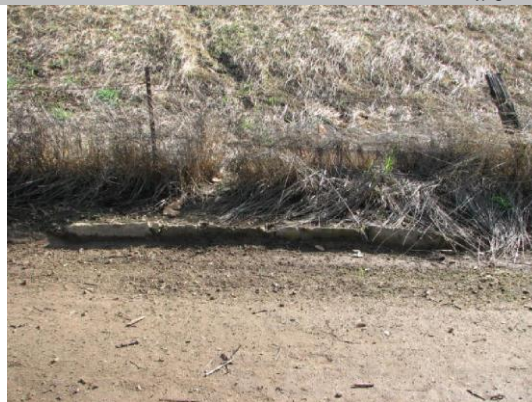
Photo 2 of 2 : UCIP\_FA\_2016\_50950\_68464.jpg

Abandoned headwall on LS toe.

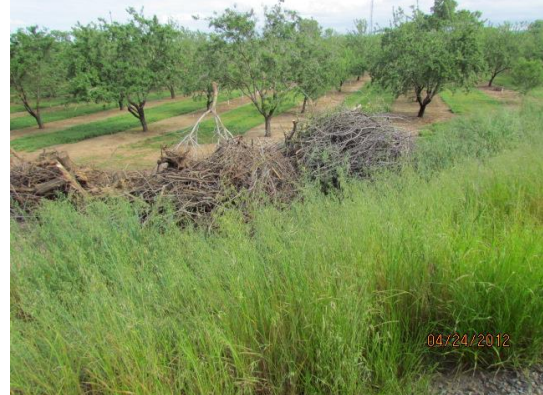
Photo 1 of 1 : FA\_2016\_MA0005\_197\_19\_20160823\_00009.jpg

View of the brush pile at the toe of the levee.

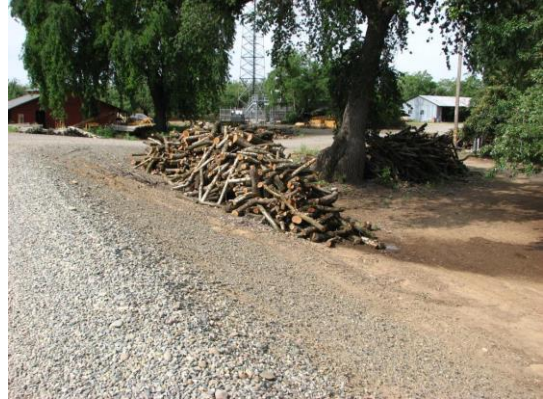
Photo 1 of 1 : FA\_2016\_MA0005\_197\_42\_20160823\_00018.jpg

View of the firewood pile at the landside toe.

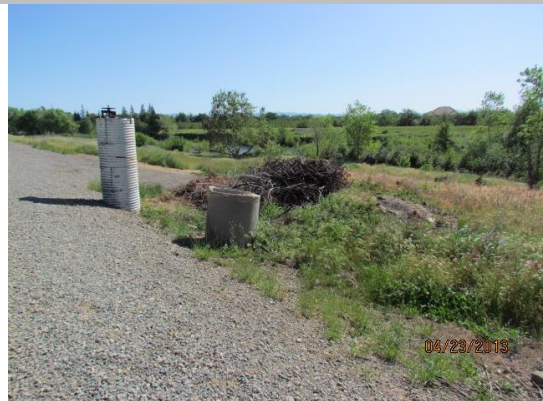
Photo 1 of 1 : FA\_2016\_MA0005\_197\_22\_20160823\_00010.jpg

View of the prunings along the waterside toe.

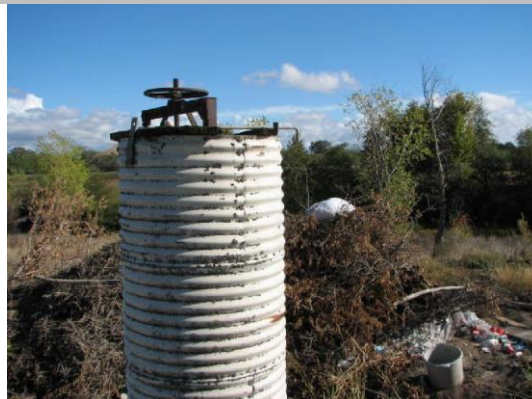
Photo 1 of 1 : UCIP\_FA\_2016\_50951\_68488.jpg

Slide gate in CM riser on WS toe.

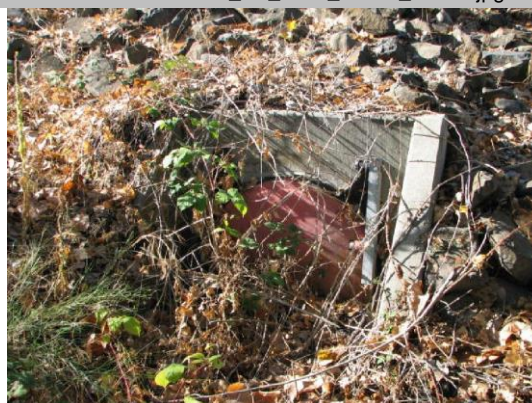
Photo 2 of 2 : UCIP\_FA\_2016\_50954\_68490.jpg

Concrete headwall and flap gate on WS slope below line of rip-rap.

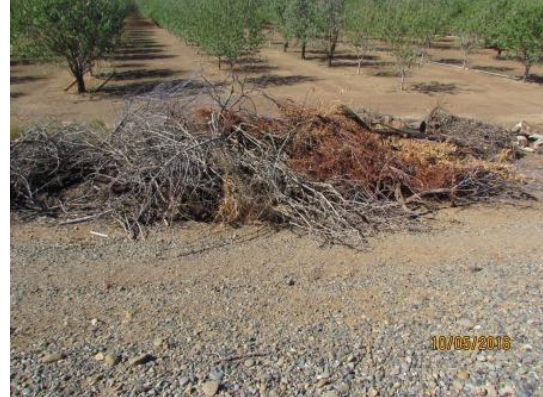
Photo 1 of 1 : FA\_2016\_MA0005\_197\_61\_20161014\_00084.jpg

View of the prunings along the landside toe.

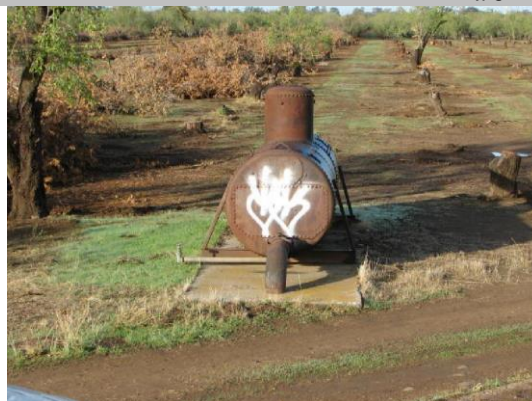
Photo 1 of 1 : UCIP\_FA\_2016\_50961\_68534.jpg

Pipe attached at boiler on LS toe.

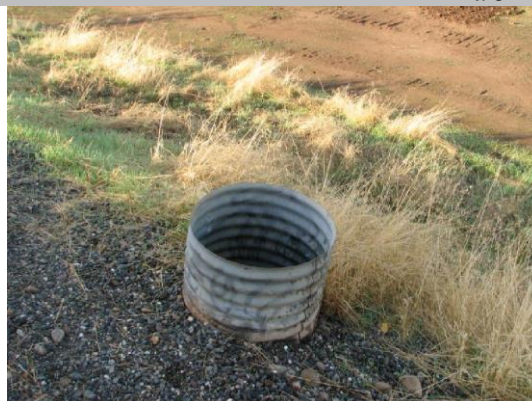
Photo 1 of 1 : UCIP\_FA\_2016\_50962\_68535.jpg

CM riser with siphon breaker on LS shoulder.

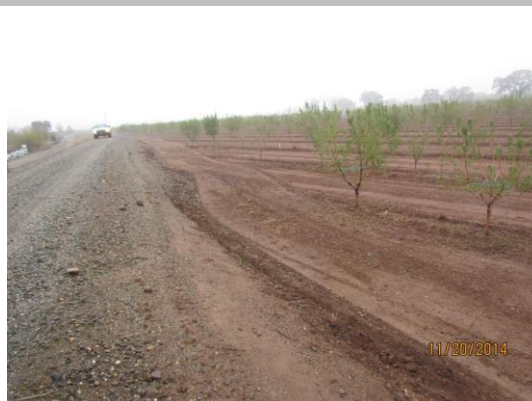
Photo 1 of 1 : FA\_2016\_MA0005\_197\_43\_20160823\_00019.jpg

View of the tilling into the landside slope.

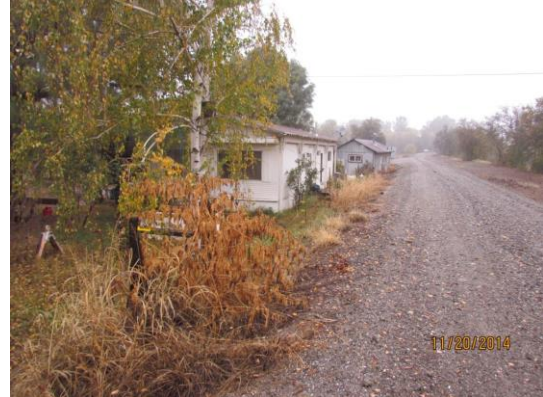
Photo 1 of 1 : FA\_2016\_MA0005\_197\_25\_20160823\_00011.jpg

View of the buildings at the landside toe.

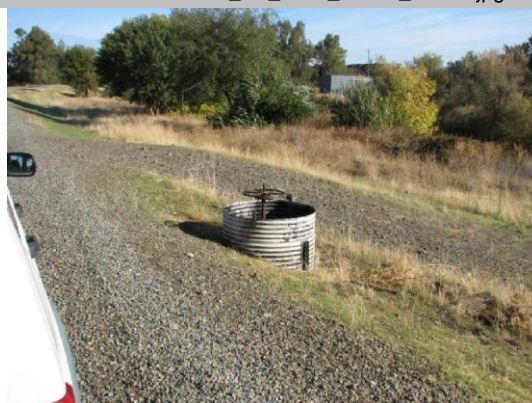
Photo 2 of 2 : UCIP\_FA\_2016\_50967\_68569.jpg

CMP riser on WS shoulder with slide gate.

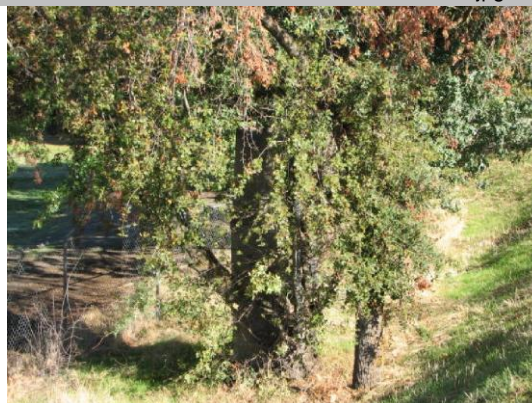
Photo 2 of 2 : UCIP\_FA\_2016\_50968\_68571.jpg

Concrete riser on LS toe.

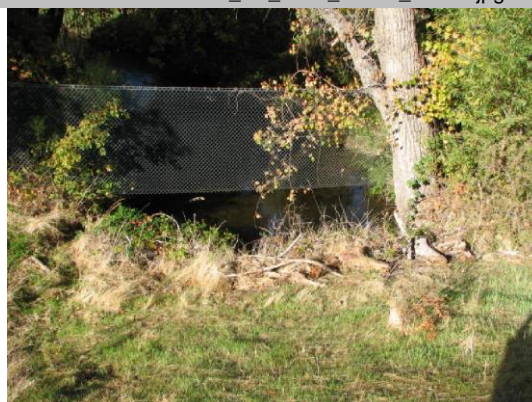
Photo 2 of 2 : UCIP\_FA\_2016\_50969\_68574.jpg

Irrigation ditch at LS toe.

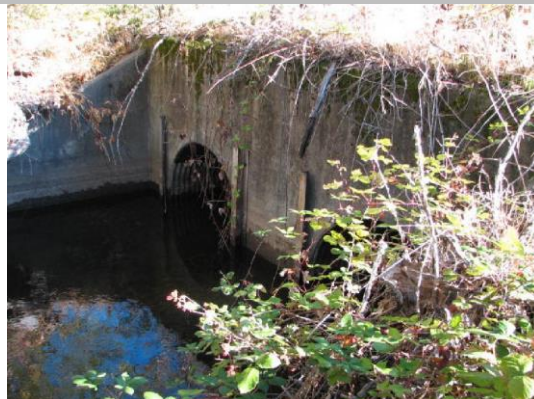
Photo 1 of 2 : UCIP\_FA\_2016\_50970\_68579.jpg

Concrete headwall at LS toe.

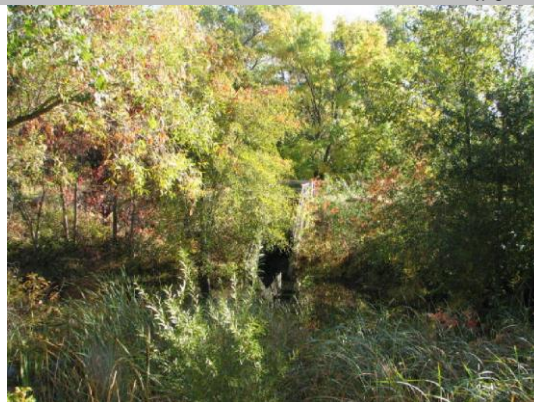
Photo 2 of 2 : UCIP\_FA\_2016\_50970\_68578.jpg

Related structure out in floodway.

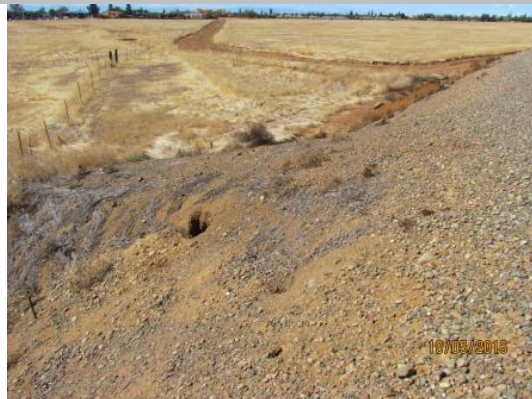
Photo 1 of 1 : FA\_2016\_MA0005\_197\_39\_20161014\_00085.jpg

View of the rodent holes along the landside slope.
